# **Dudley Digges House**

aka Bray School and Brown Hall Annex

524 Prince George Street Williamsburg, Virginia

# Room-by-Room Inventory of the Building Fabric

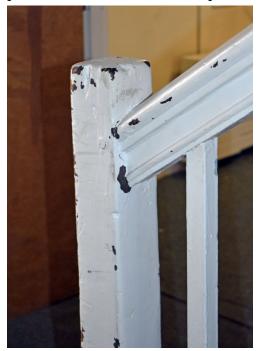
flight to the landing at the back of the passage. The oldest features are the 3½- inch square newel posts, which show signs of heavy wear and the molded handrail, which has an eighteenth-century profile with raised and rounded top, torus edges and an astral on it the lower sides. The stair has one-inch square balusters that are 1 foot 11 inches in height and are likely replacements dating from the early nineteenth century, when such forms replaced turned urn and baluster ones. There is a heavy build-up of paint where the balusters are attached to the top of the string. The stringer has a distinctive ghost mark that runs parallel to the slope of the stair that suggests are earlier arrangement of a decorative piece attached to its side.

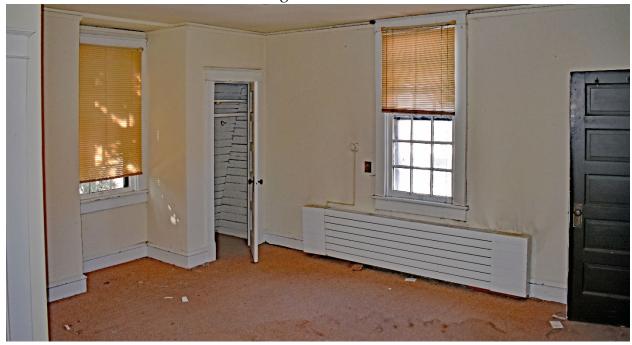
Room 204 is the northernmost second-floor room in the house. It was part of the side wing added in 1926-27 when the Digges House was converted into a women's dormitory by the Woman's Missionary Society of the Methodist Church. This room served as a chamber and featured a bathroom in the one corner of the room with two closets at the in the corner of the outer gable end wall.

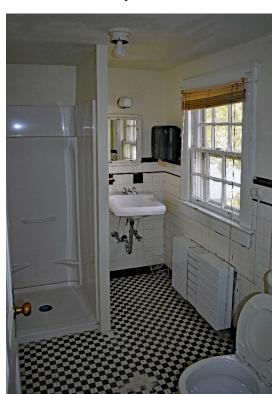
Room 205A is a part of the 1920s back wing addition. It is located on the north west side of the building, next to Room 205 and across the back passage from Room 202. It was originally built as a bathroom as evidenced by the small window on the north wall and the early tile floor walls and floor and plumbing fixtures.

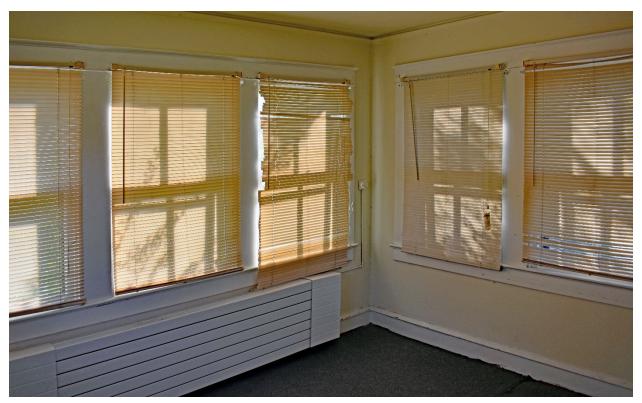
Room 206 was originally used as a sleeping porch on the second floor added in Period V in the early 1930s after the house had been moved to its present site. The room is an addition on the south side of the house. Three of the walls are lit by bands of windows. A partition wall was added to create a bathroom within the room afterward in the late 1930s (Period VI). To the right of the entrance door there is a closet (that dates from the early 1920s expansion) and to the left is the entrance to the later bathroom.

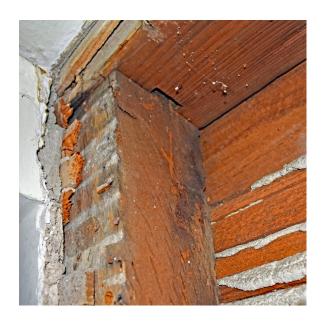
sw corner post tenoned into the plate

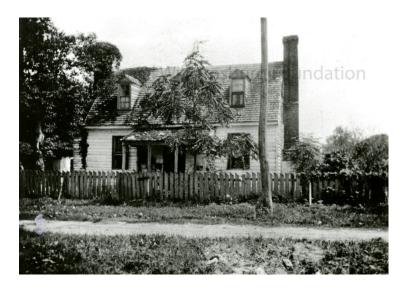
Digges House, before 1924, on its original site at the southeast corner of Prince George and Boundary Streets.

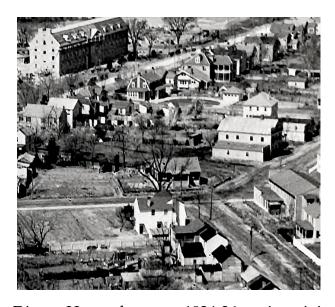
Digges House, between 1924-26, on its original site. Gambrel roof added along with two-story rear wing. In 1930 it would be moved a half block to the nw a located between the 2-story frame house and the pyramidal roof frame house in the upper right-hand corner of the photograph.

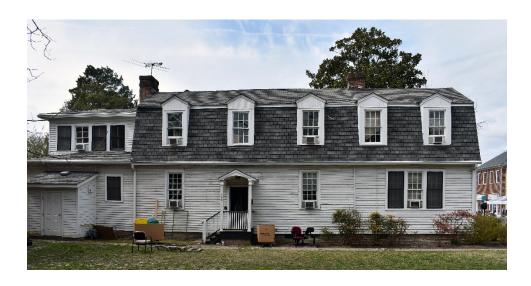
East front of house, March 2021.

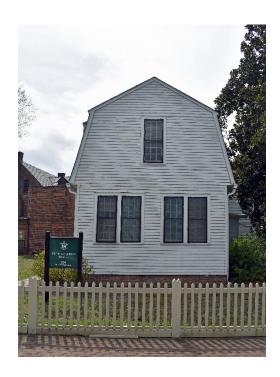
North end, 1926/27 wing.

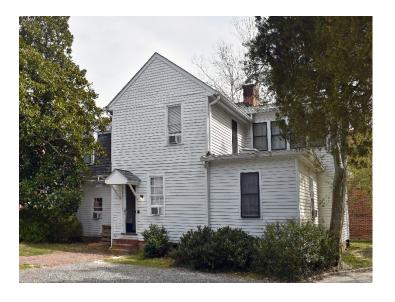
West, rear façade of house; with two-story rear wing added c. 1924, and one-story addition to the right built in the late 1930s or early 1940s.

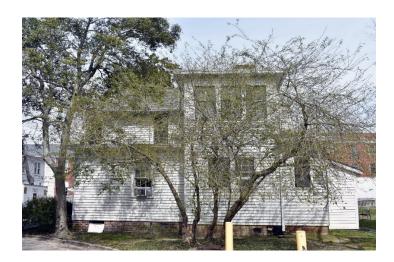
South end of house; two-story central block and onestory section to the right built on this site by the college between 1930-1933; one-story section to left added in the late 1930s or early 1940s.
